STOREFRONT REHABILITATION AND DESIGN

LEARNING OBJECTIVES

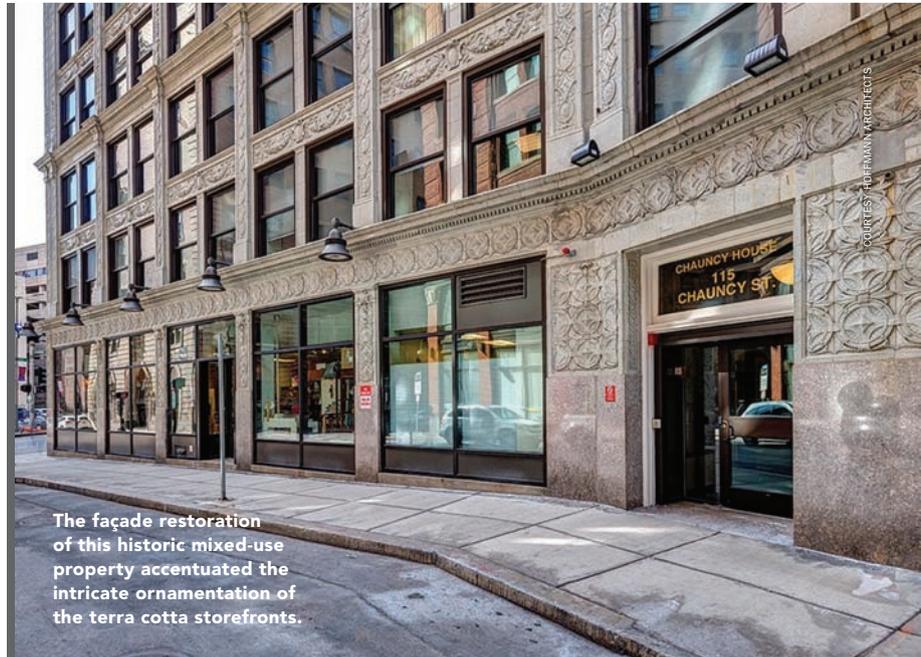
The façade restoration of this historic mixed-use property accentuated the intricate ornamentation of the terra cotta storefronts.

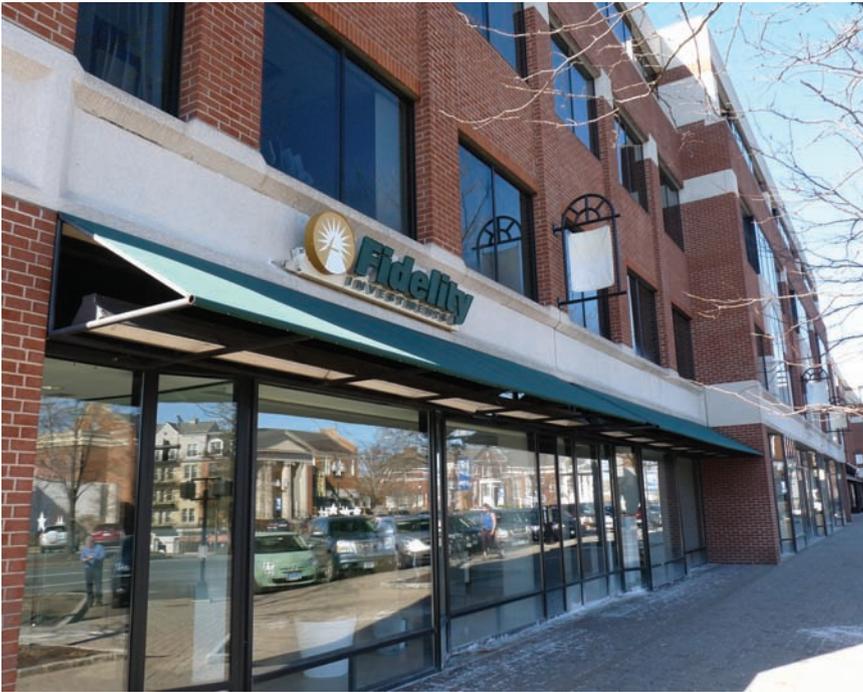
Leaks at windows, doors, and along the base of walls may be temporarily addressed with stopgap measures, but eventually full replacement of a poorly performing storefront assembly may be necessary.

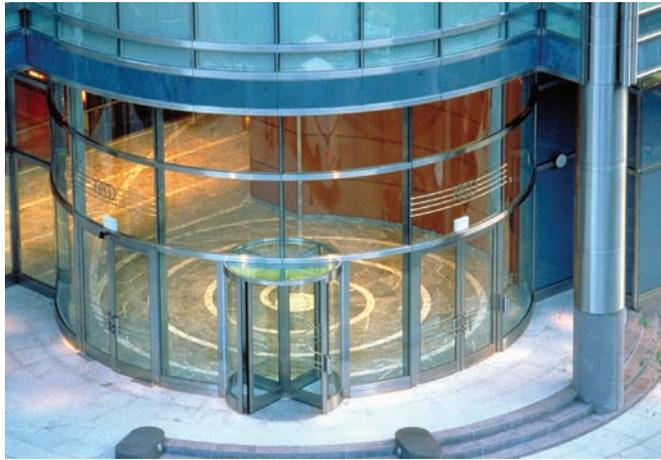
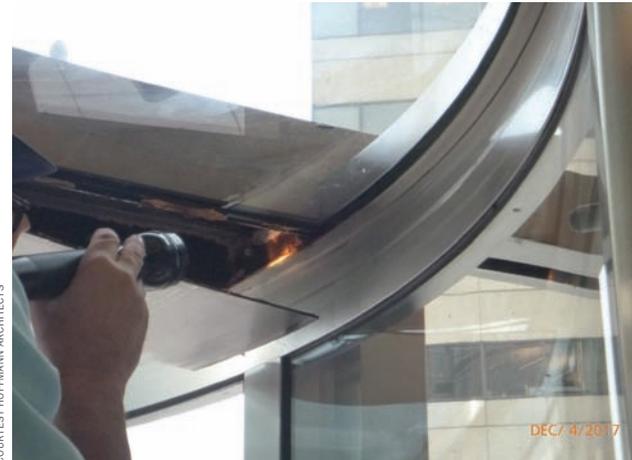
Investigation of the poorly functioning revolving door at this office complex revealed extensive corrosion.

• **Revolving doors.** For buildings with significant traffic, such as commercial buildings, hotels, shopping malls, and hospitals, revolving doors can mitigate strong positive and negative pressures. Where HVAC and outdoor conditions would cause excessive wear and tear on a typical door, revolving doors permit high-volume usage without compromising indoor climate. Automatic revolving doors provide ADA-compliant operation while managing heavy traffic.

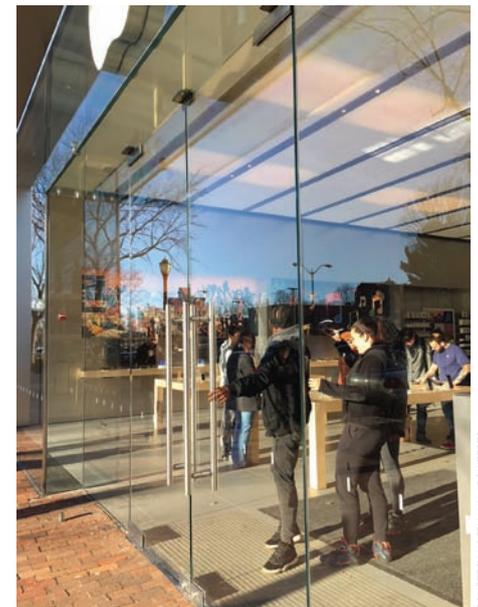
Without weatherstripping, these doors look sleek, but air infiltration may be an issue.

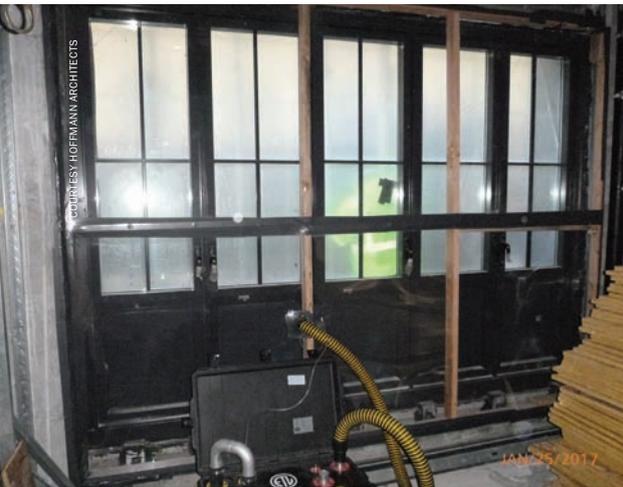
Field tests confirm the storefront meets performance standards.

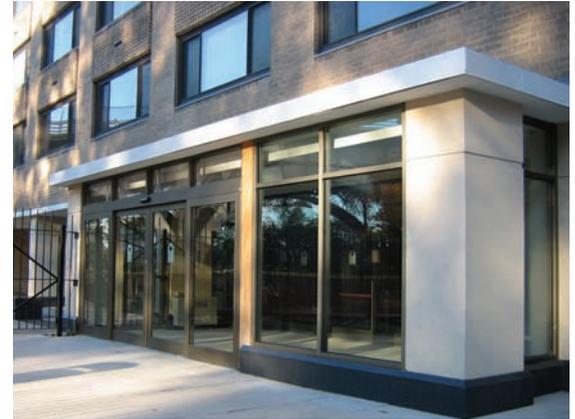
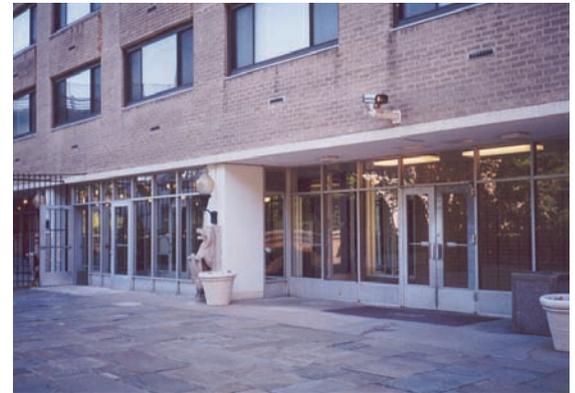
Replacement of this aging storefront demanded modifications to the new assembly for operation in strong wind.

subjected to strong forces when open, taxing the hardware and leading to constant maintenance repairs or replacement. In this location, a balanced door, while more expensive at the outset, might prove less costly in the long term, as its resistance to wind pressure could mean longer lifespan and fewer repairs.

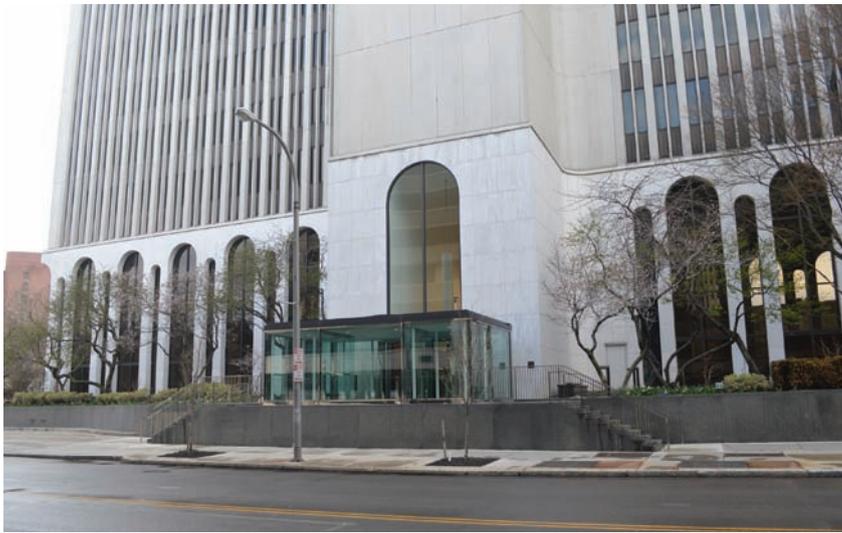
The award-winning storefront entrance redesign at this Modern-era landmark maintained the aesthetic of the original while improving thermal regulation and pedestrian traffic flow.
